TESTS REPORT

Ref : 0-2182

Company : Chenn Daa Co

CONCERNING : IMPACT TEST ON BICYCLE WHEELS

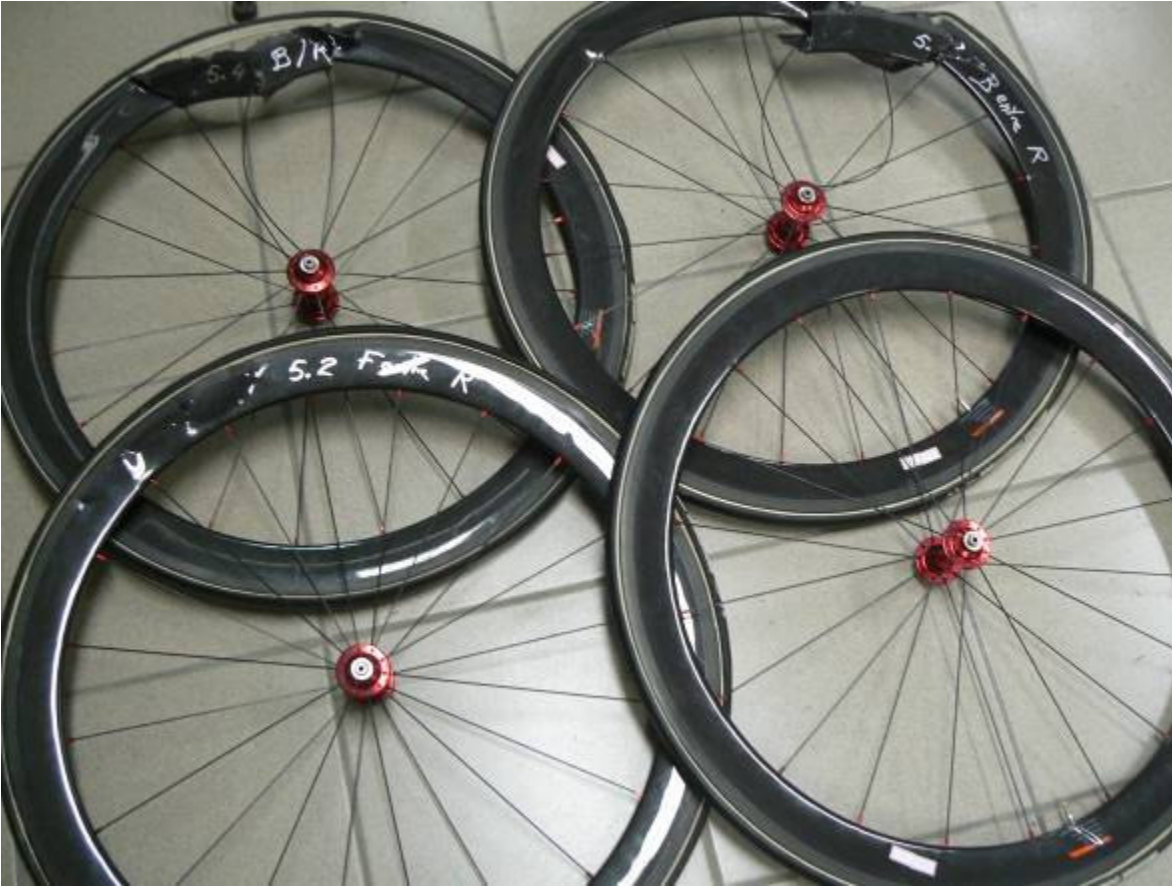
**Front position**

<p>The rim presents a crack on the circumference.                  Very good behaviour of the wheel.</p>	<p>The rim presents some cracks on the circumference.</p>

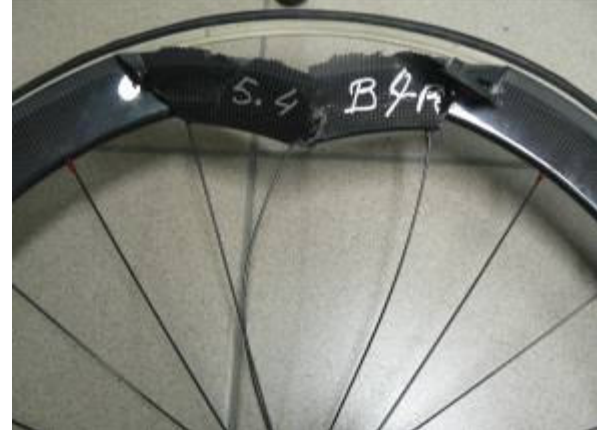
<p>The rim is crushed and presents a failure.                  The cohesion of the wheel is kept.</p>	<p>The rim is crushed and presents a failure.                  The cohesion of the wheel is kept</p>
