TESTS REPORT

Ref : 0-2182

Company : Chenn Daa Co

CONCERNING : IMPACT TEST ON BICYCLE WHEELS

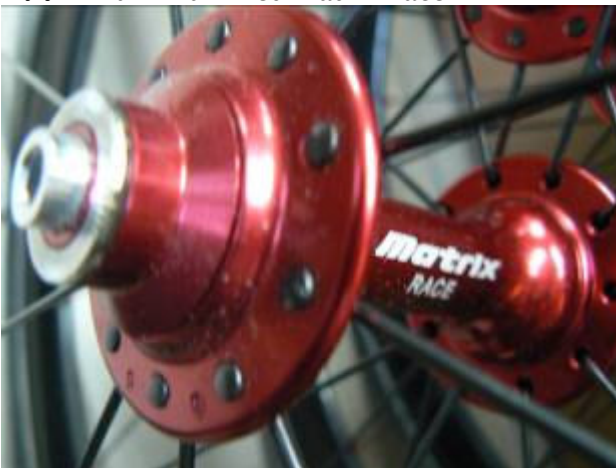
**Chenn Daa Co Matrix T50**

Carbon rim  $\pm$  50mm

Tubular tyre

20 Aluminium spokes length: 250mm – Diameter 1.80mm

Total weight tires included 0.950kg

Wheel diameter  $\pm$  635mm

**Hub** : Aluminium Red Matrix Race
